Re: **Augmentation of Gravel Thickness**

SUMMARY REPORT

GRAVEL ADDITION IMPLEMENTATION AND CONFIRMATION

SOLUTIA INC. W.G. KRUMMRICH FACILITY SAUGET. ILLINOIS

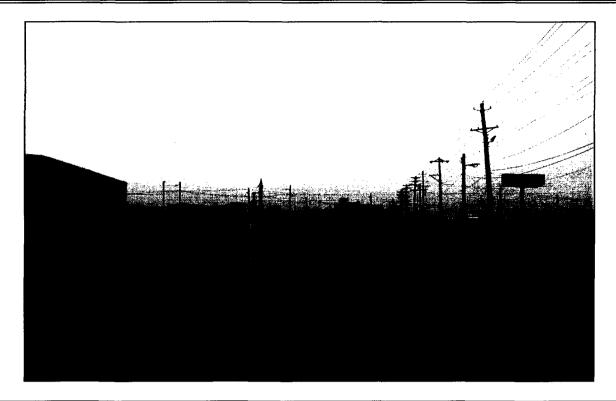
Photo 1

Area 1

Looking south at the compacted gravel between Building BBU and Route 3

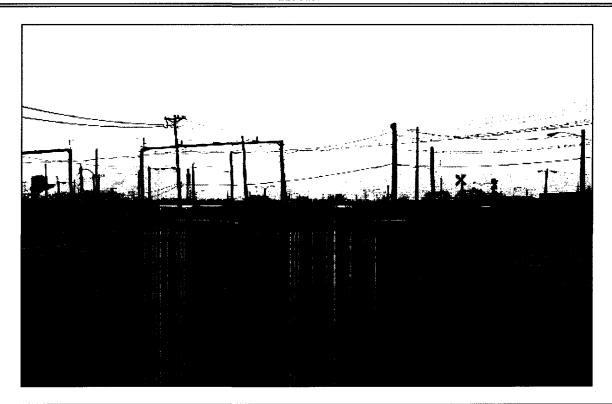
Photo 9

Area 7

Photograph of compacted limestone screening in Area 7

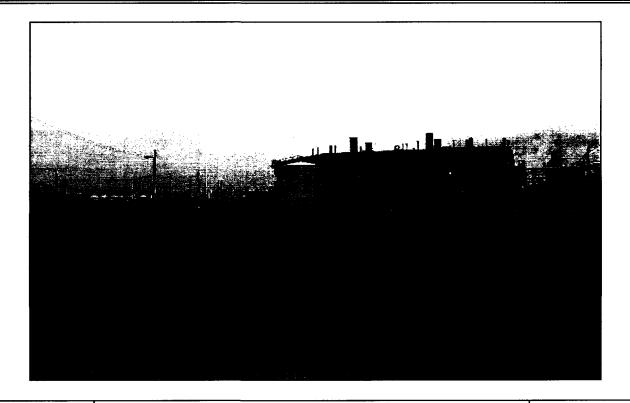
Photo 10

Area 9

Looking west at compacted limestone screenings

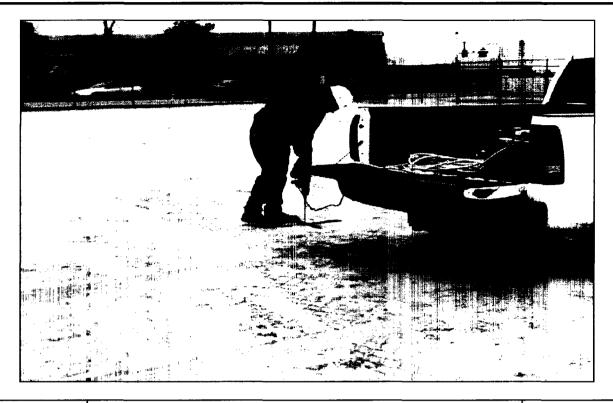
Photo 11

Nov-03 Area 9
Photograph of a confirmation boring being drilled in Area 9

The subsurface investigation at the approximate location of each applicable sampling point was performed by the use of a hand-held rotary hammer utilizing a ½-inch diameter drill bit. The drill bit was advanced to the bottom of gravel, refusal or 12 inches below ground surface, whichever occurred first. The thickness of gravel at each boring location was measured and recorded. Each borehole was backfilled with the materials removed from the hole during drilling and the surface was smoothed to match surrounding grade.
